Manhole Inspection Summary

Manhole # S21K__046MH

Insp Date: **9/26/07 11:37 AM**

Location Address: **127 FULTON AVE**

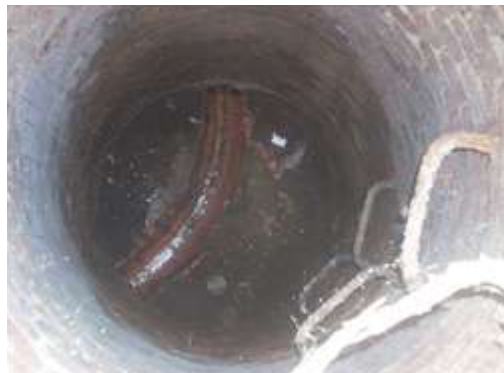
Top View

worn frame

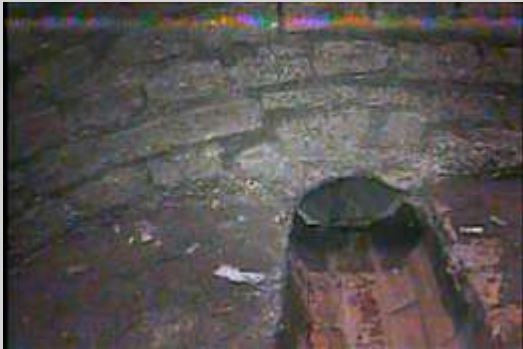
12 O'Clock Outflow

8 in. Circular Gravity Sewer
Pipe Out @ 12 O'Clock

Pipe Height: **8.4** (in.) Rod and Bar (Angled)
Pipe Material: **Clay** ☐ Pipe Lined
Invert Depth: **10.58** (ft.) Flow Characteristics: **Slow**
Deposits: ☒ None ☐ Mud ☐ Sludge ☐ Debris ☐ Grease
Silt Depth: (in.) Deposits Extent:
Infiltration: **None** Pipe Seal Cond: **Sound**
